# Manhole Inspection Summary

Manhole # S45CC\_021MH

Insp Date: **3/11/08 12:49 PM**

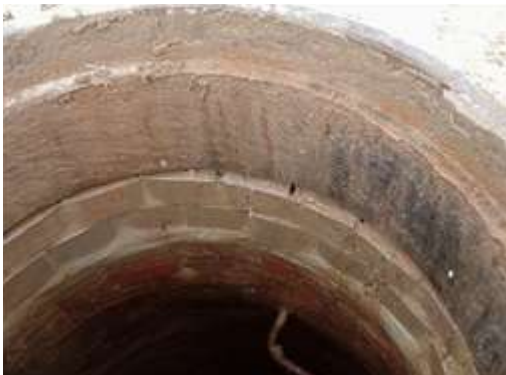
Defect 2

☒ **Leaks**

frame leaks

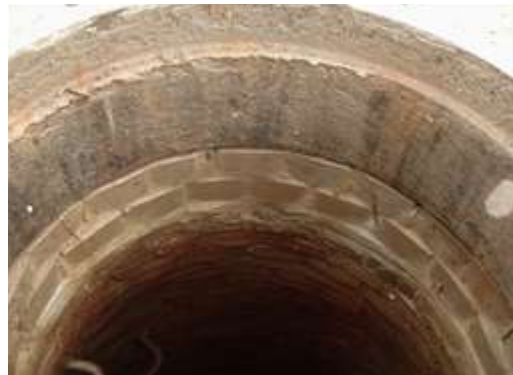
Defect 1

Infiltration: ☐ None ☐ Joint ☐ Cracks ☐ Mortar ☐ Roots ☒ **Wall**

adjustment joints

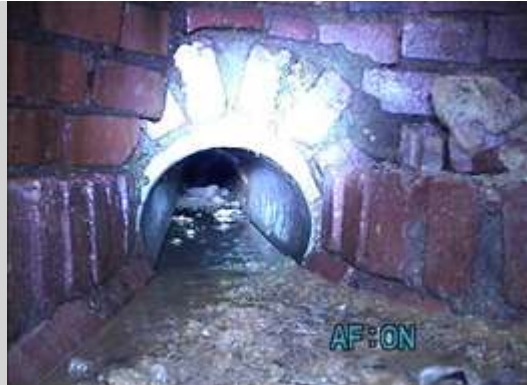
12 O'Clock Outflow

Pipe Height: **8.4** (in.) Rod and Bar (Angled)  
Pipe Material: **Clay** ☐ Pipe Lined  
Invert Depth: **11.20** (ft.) Flow Characteristics: **None**  
Deposits: ☐ None ☒ **Mud** ☒ **Gravy** ☒ **Debris** ☐ Grease  
Silt Depth: **2** (in.) Deposits Extent: **Light**  
Infiltration: **Evidence** Pipe Seal Cond: **Sound**

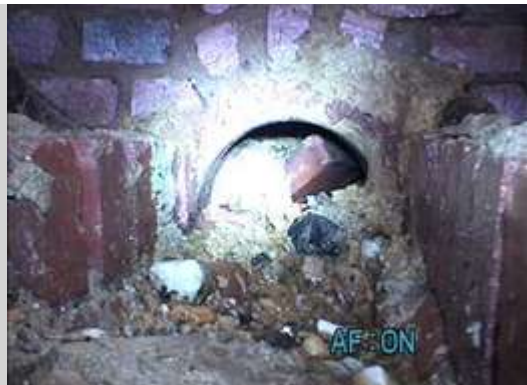
3 O'Clock Inflow

Pipe Height: **8.4** (in.) Rod and Bar (Angled)  
Pipe Material: **Clay** ☐ Pipe Lined  
Invert Depth: **11.25** (ft.) Flow Characteristics: **None**  
Deposits: ☐ None ☒ **Mud** ☒ **Gravy** ☒ **Debris** ☐ Grease  
Silt Depth: **7.5** (in.) Deposits Extent: **Heavy**  
Infiltration: **None** Pipe Seal Cond: **Sound**

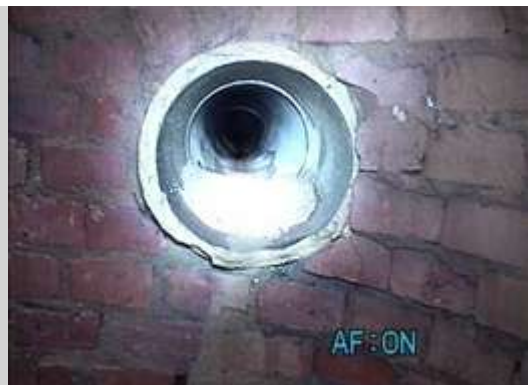
6 O'Clock Inflow

Deposits: ☐ None ☒ **Mud** ☒ **Sludge** ☐ Debris ☐ Grease

Silt Depth: **1** (in.) Deposits Extent: **Light**

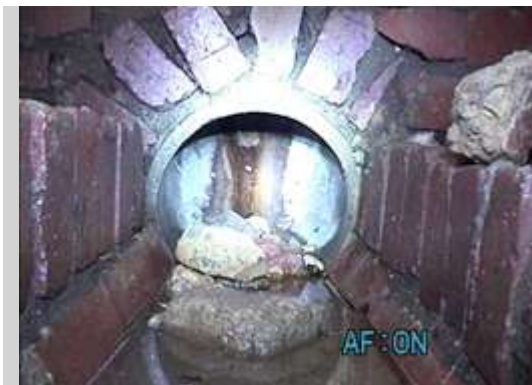
Drop In @ 6 O'Clock

Drop: <b>Inside</b>	Rod and Bar
Angled: <b>Yes</b>	Reading: <b>10.10</b> (ft.)
	Inv Depth: <b>11.10</b> (ft.)
Drop Condition: <b>Partly Clogged</b>
